**Central of Georgia
Savannah Repair Shops and Passenger Station
Historic Building Inventory and Phases of Construction**

Historic Site Plans And Aerial Photographs

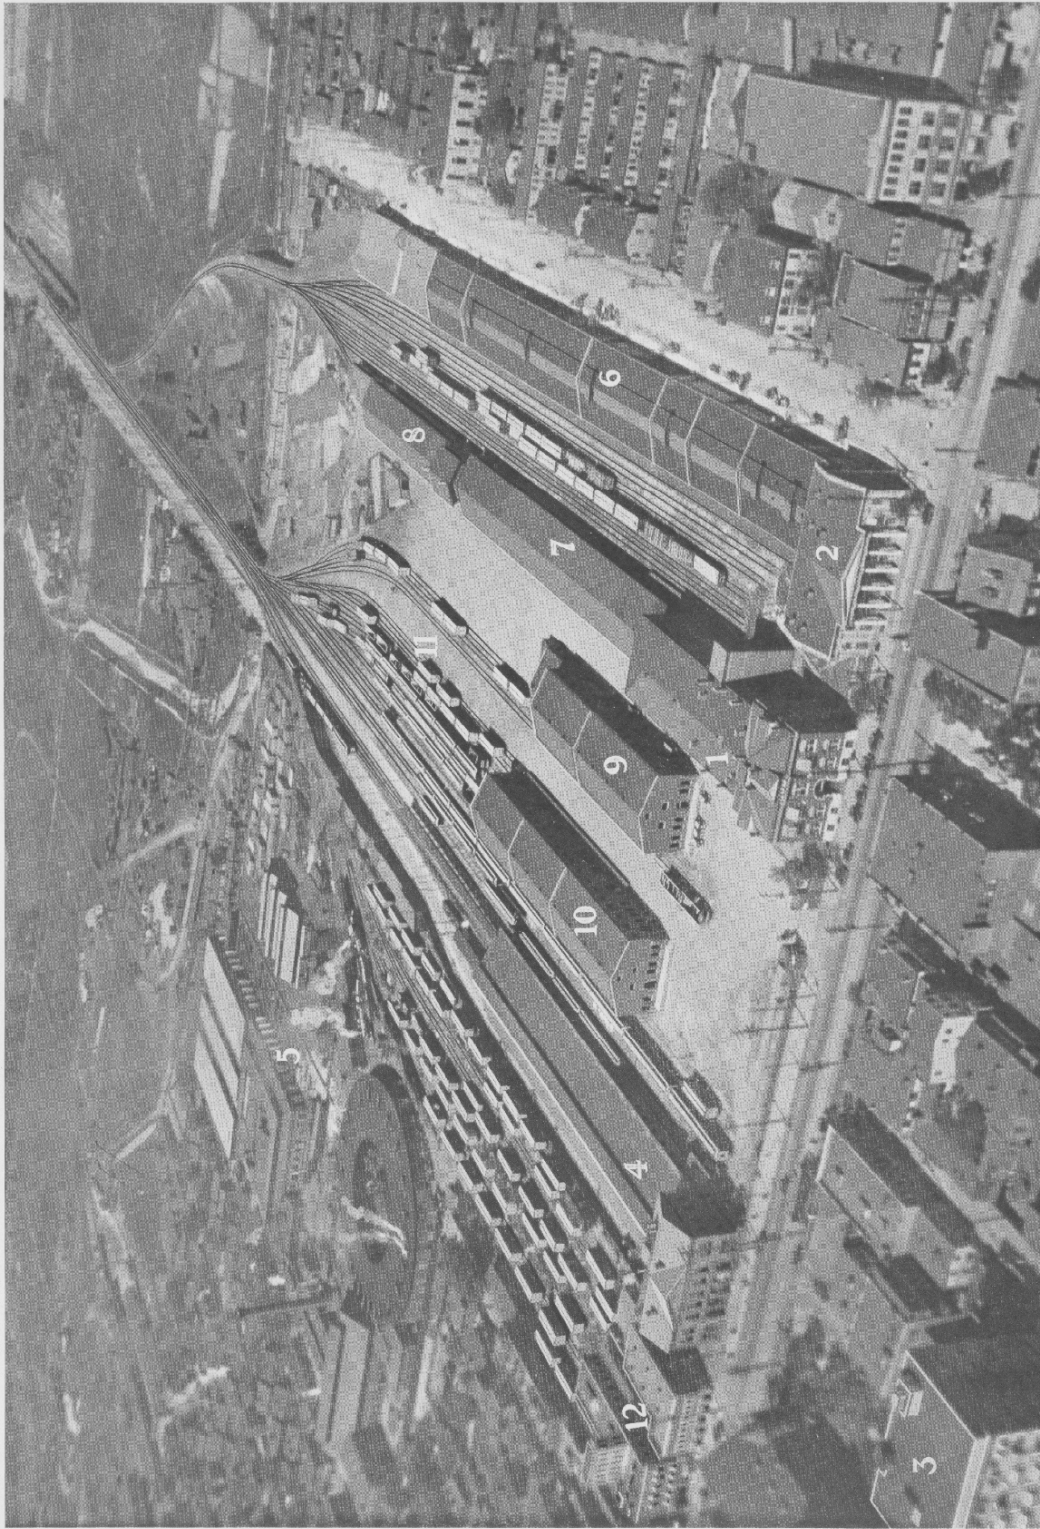
Aerial Photograph, 1923.

VIEW OF CENTRAL OF GEORGIA RAILWAY GENERAL OFFICE BUILDINGS, SHOPS, WEST BROAD STREET YARDS AND WAREHOUSES: 1, 2 and 3—General Offices, 4—Passenger Station, 5—Shops, 6—New Street Warehouse occupied by Ballard & Ballard, J. G. Butler Builders Supply Company, Carlyle Provision Company, Haas-Guthman Company, M. S. Hermon & Bro., S. A. Kantzper, W. L. Poythress, and Unity Grocery Company, 7—Central of Georgia Railway storage warehouse 12, 8—Warehouses of Burns & Harmon, W. F. Cardinal, I. D. Hirsch and Frank Palmer, 9—Warehouse of R. C. Williams Georgia Corporation, 10—Warehouse of Semmes Hardware Company, 11—West Broad Street Team Tracks, 12—Plants of Armour & Company, Cudahy Packing Company, Morris & Company, Swift & Company and Wilson & Company.

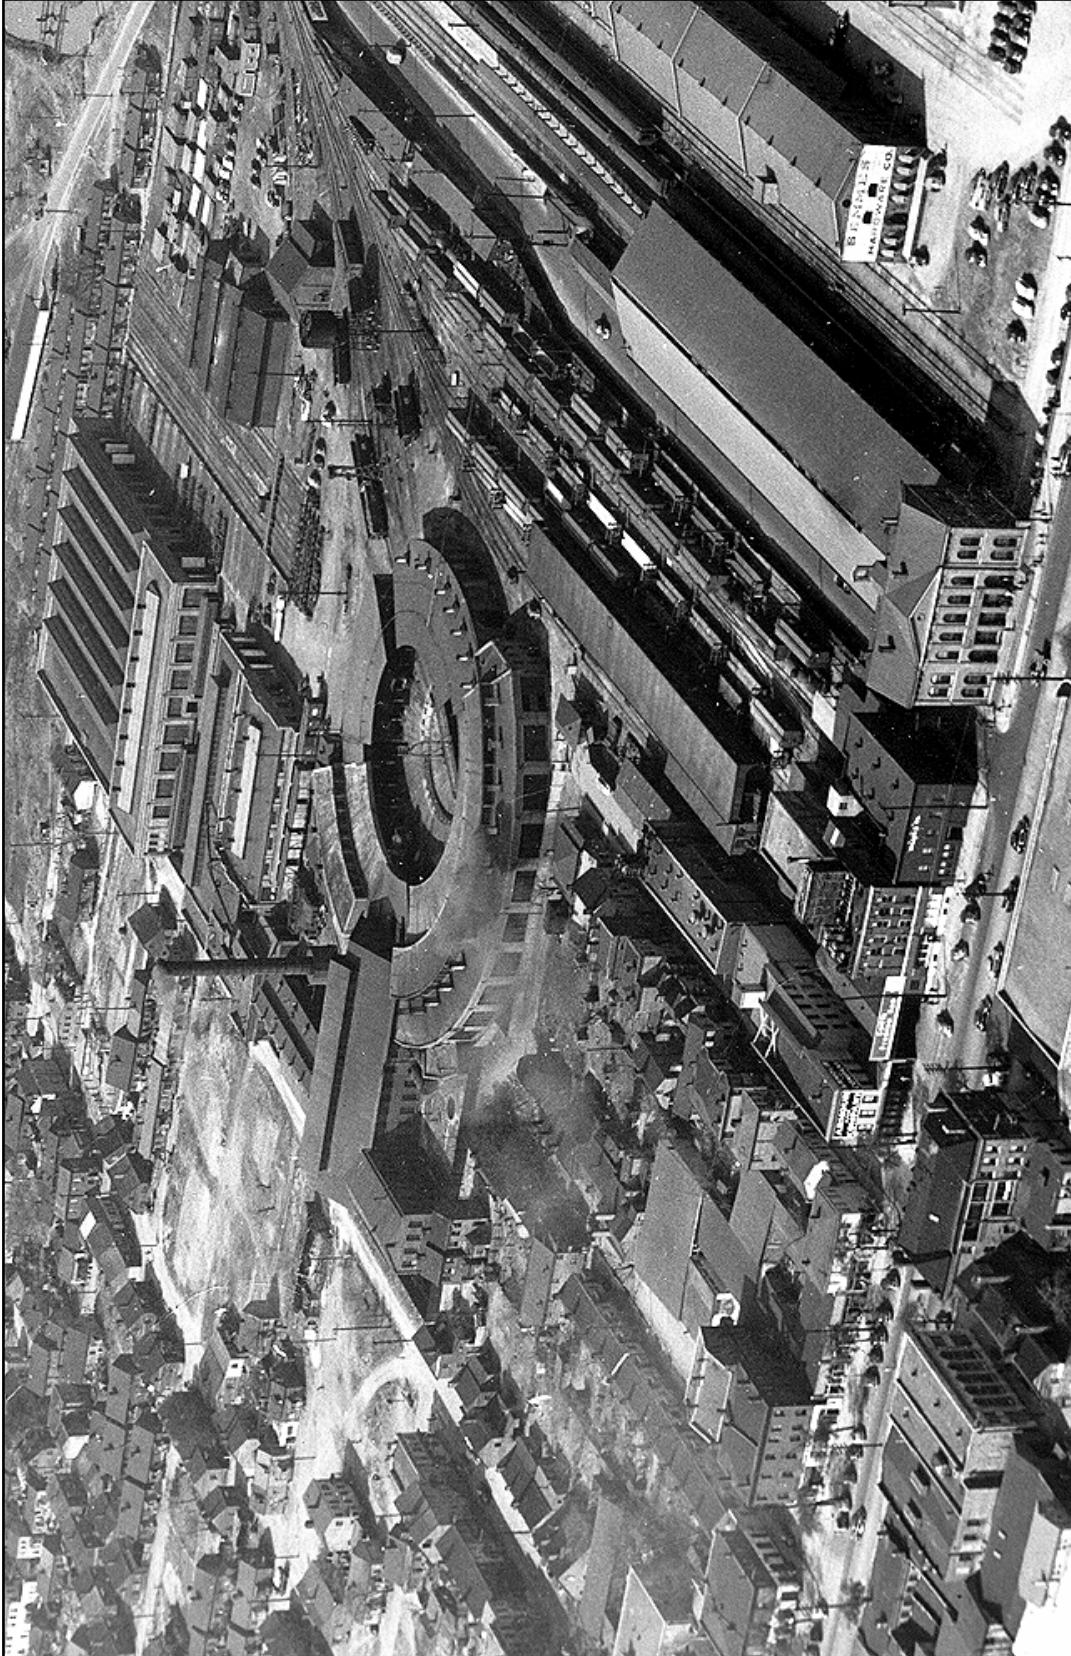
Aerial Photograph, ca. 1950

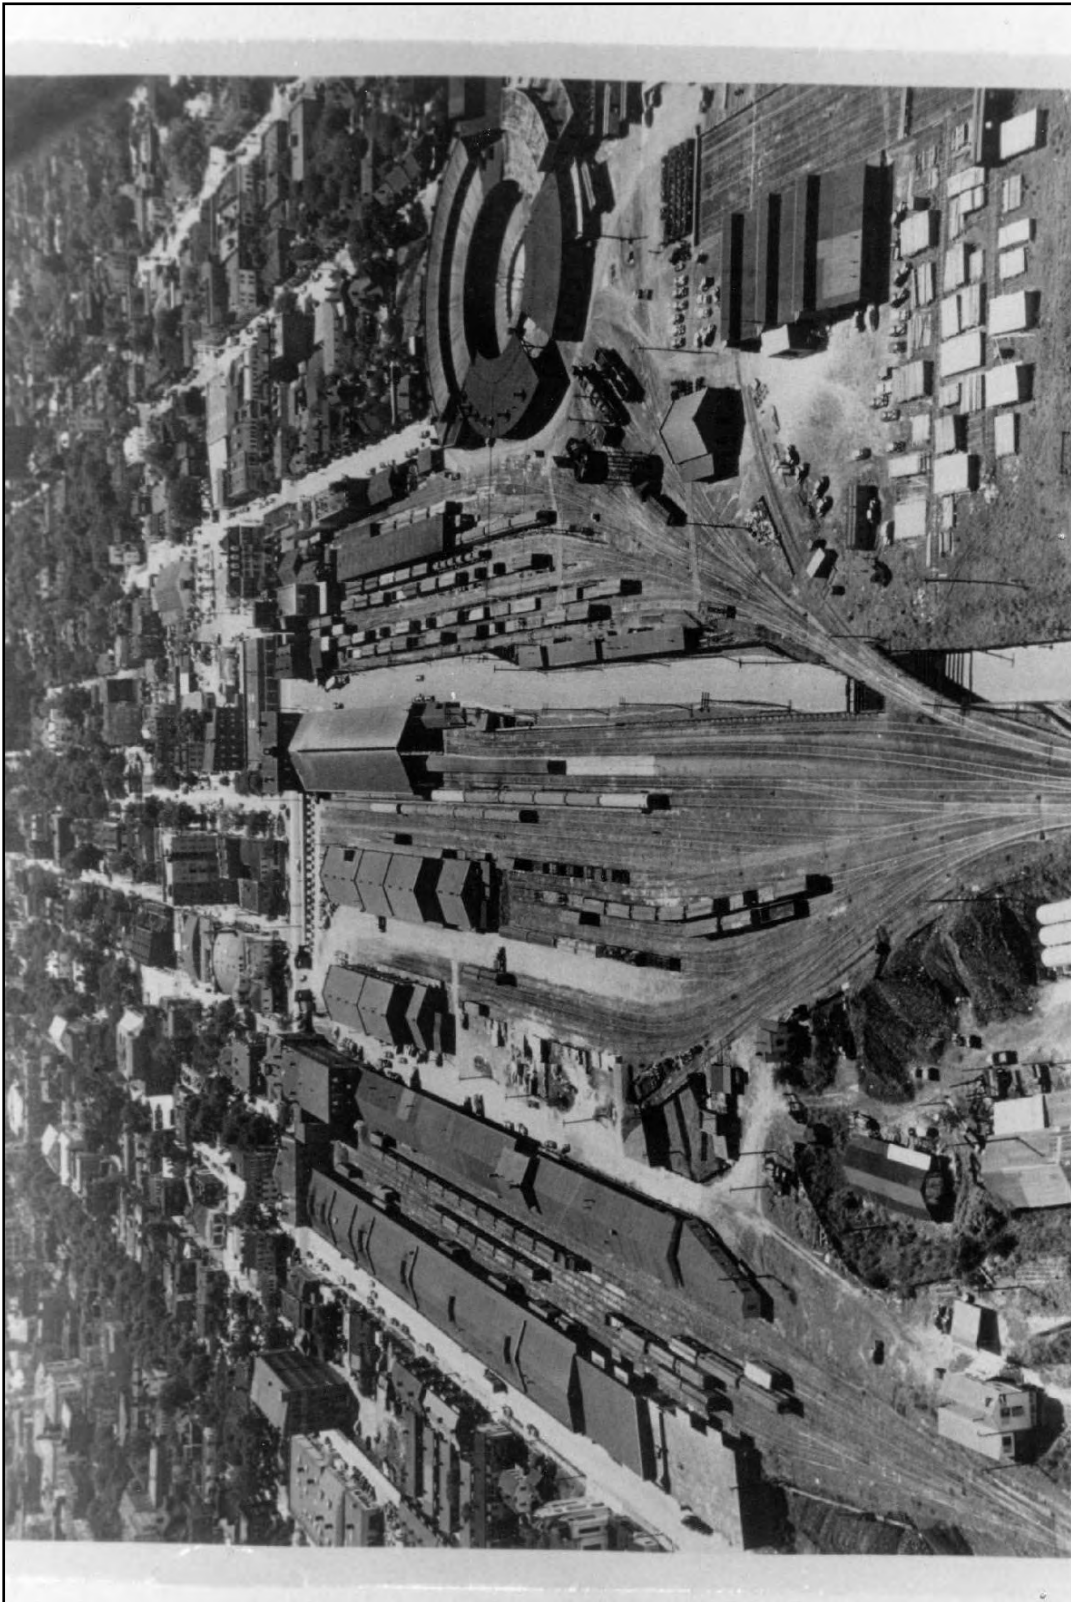
Aerial Photograph, ca. 1950
